**REASONS FOR DAMAGES AND DESTRUCTIONS CAUSED  
BY RECENT EARTQUAKES AFFECTING BULGARIAN TERRITORY**

Dimitre Nenov<sup>1</sup>

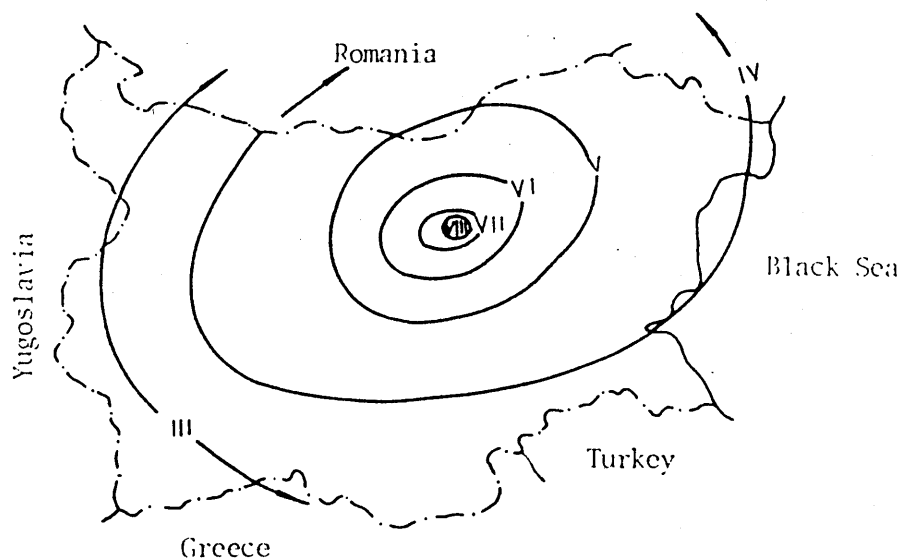
Fig. 2 The isoseismals map of December 1986 earthquake

The isoseismal map of December 1986 earthquake shows that it has been felt all over the Bulgarian territory (fig.2). The earthquakes caused serious damages and destructions. More than 24000 residential, public, industrial and agricultural buildings were affected in more than 20 towns and villages. Half of them have been declared unfit for dwelling and the other half needs serious strengthening or repairing.

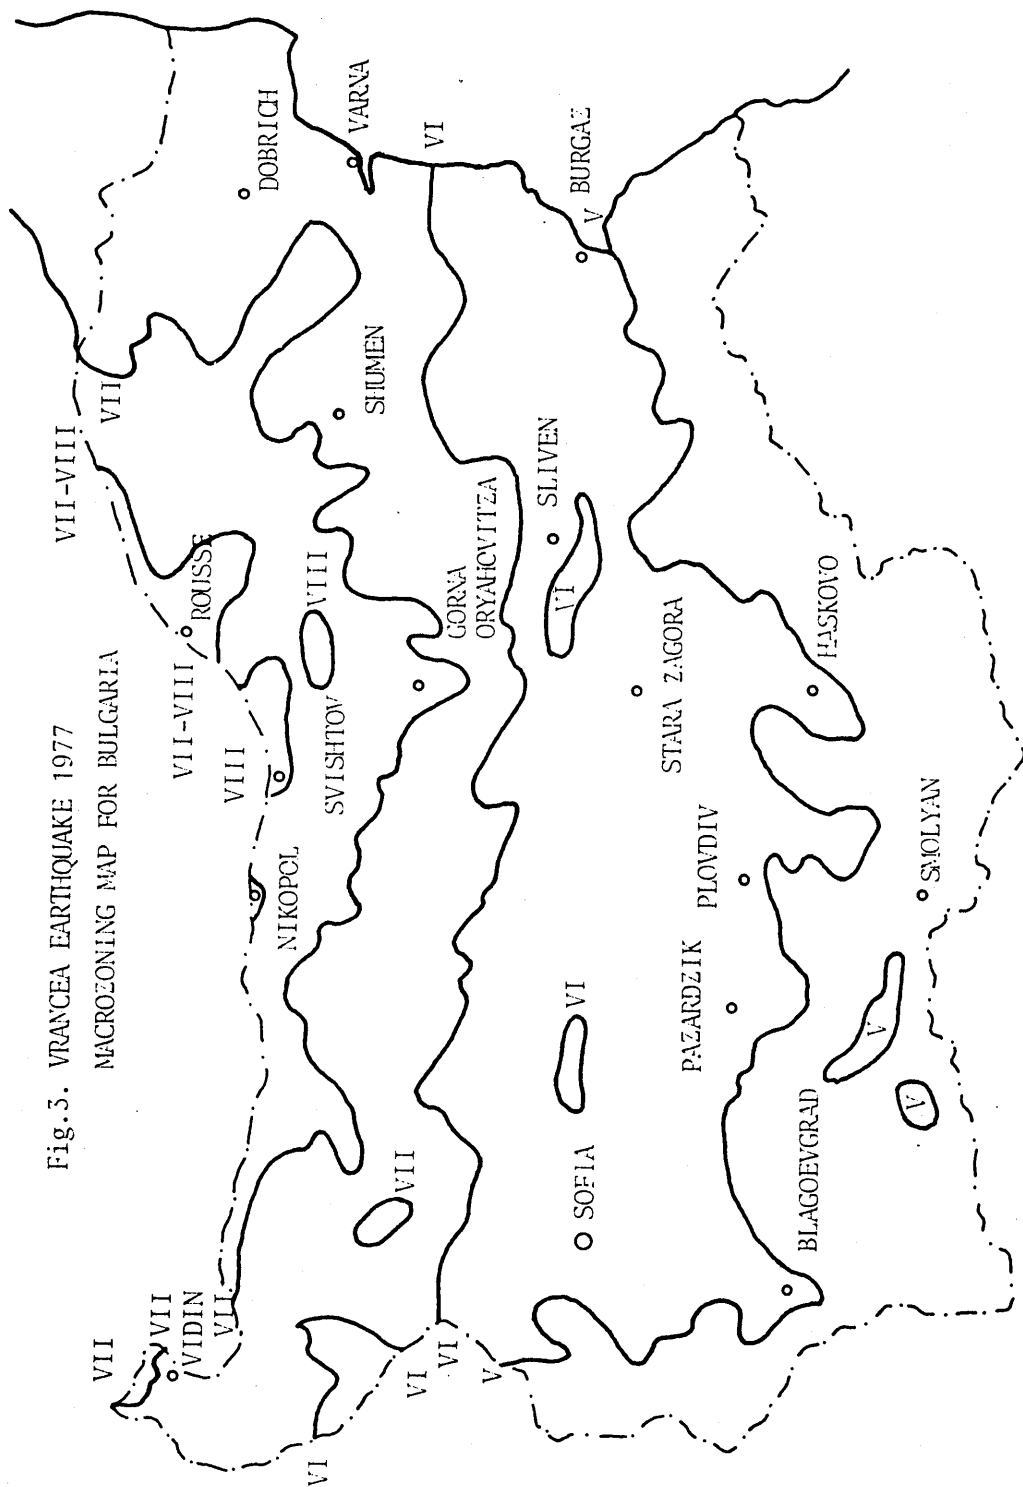
Fig. 3. VRANCEA EARTHQUAKE 1977

The Vrancea earthquake of March, 4th, 1977 had a focal depth of about 110 km and a multishock mechanism with a main shock magnitude 7.2. Maximum horizontal accelerations of 0.2g on the N-S direction and 0.16g on the E-W direction as well as a vertical acceleration of 0.1g were recorded at INCERC, Bucharest. The seismic movement shows predominant vibration periods of 1sec to 1.6 sec (in Bulgaria up to 2.4sec). That earthquake affected the whole Bulgarian territory (fig.3) with intensities of IV to VIII degree. One can see that a characteristic feature of the map is the asymmetric intensity distribution.
