STRUCTURAL FIELD STUDIES AFTER THE ERZINCAN TURKEY EARTHQUAKE OF 13TH MARCH 1992

Edmund Booth (Ove Arup & Partners, London)

ABSTRACT

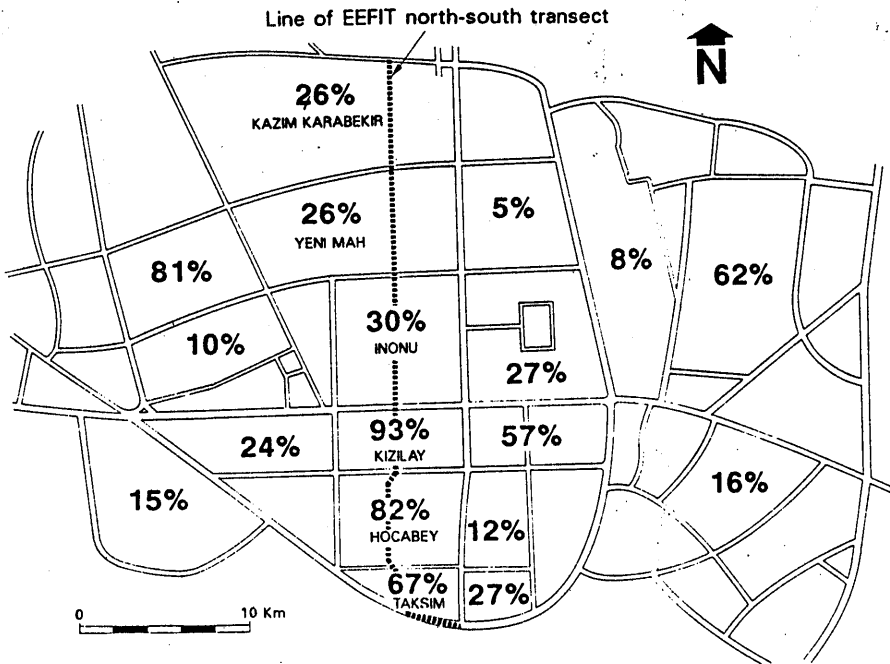
Figure 1 Line of north-south transect survey through Erzincan. Also shown are percentage of buildings damaged in each district (from Yuzugulu et al, 1992)

A simple damage survey was made to try and establish whether ground motions in Erzincan had varied systematically with distance from the edge of the Erzincan basin. The survey was conducted along a north south line across the city, just to the west of the city centre (figure 1). Based on a hydrogeological survey map dated 1981, it appears that the depth of sedimentary material varied considerably along the survey line (Figure 2).

For comparison, the percentage of damaged (light, heavy and total collapsed) buildings recorded by Yuzugulu et al (1992) in Erzincan is shown in Figure 1. No clear trend can be seen, with the damage level probably reflecting type of construction rather than distance from the northern edge of the basin.

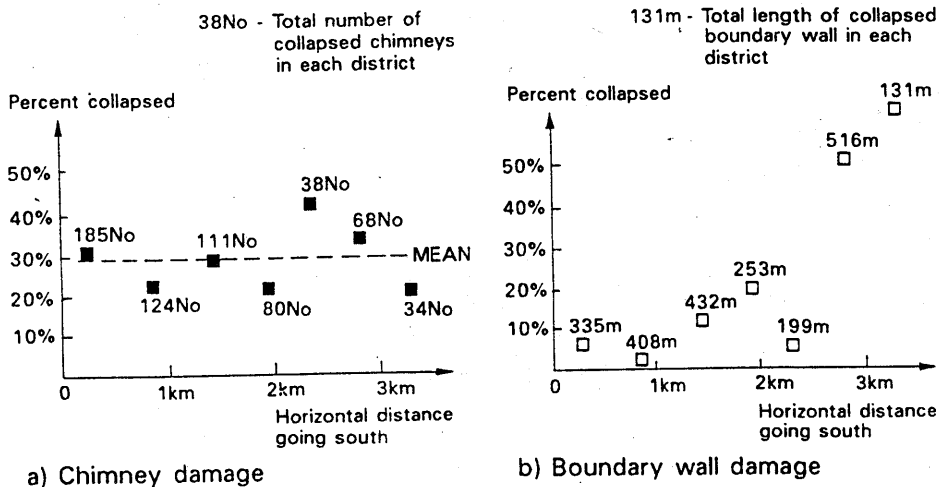
Figure 3 Damage survey along north-south transect through Erzincan

The results of the survey are plotted in figure 3. The results are not conclusive; the chimney survey shows no significant variation of damage with distance from the edge of the basin while the boundary fence survey suggests some increase in motion at the southern end of the survey line. It is likely that more reliance can be placed on the chimney survey because the high damage level of walls to the south may be a result of softness in the uppermost layers of soil, in lower lying areas, which would not necessarily affect chimney response. Certainly, the absence of trend in the chimney damage suggests that any tendency of the motions to increase with distance from the edge of the basin was low.

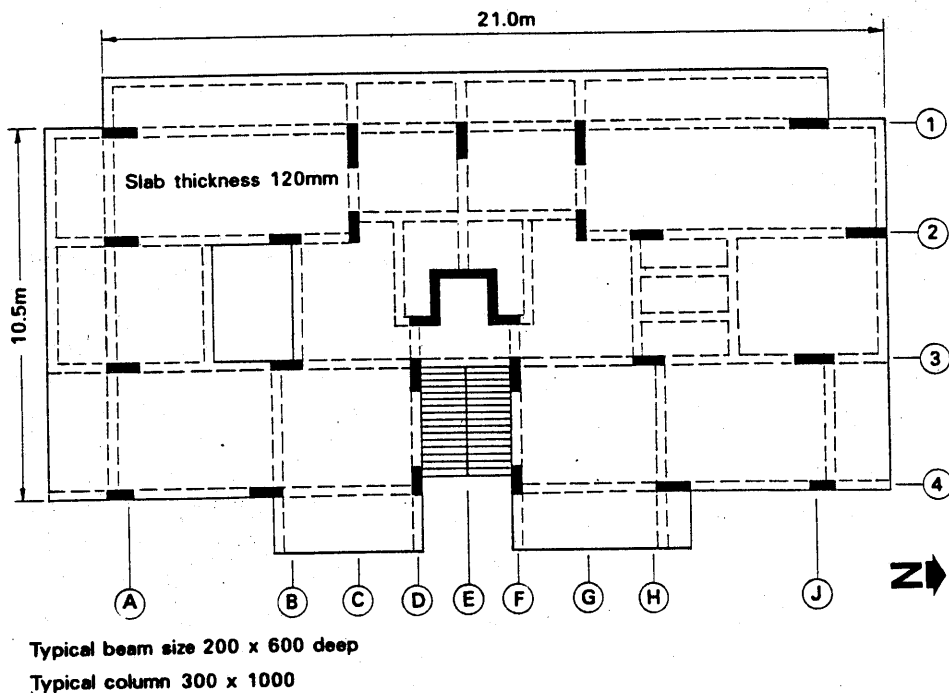
Figure 4 shows the first floor plan, based on a site survey using only a tape measure. The vertical structure started at basement level and continued essentially undiminished to roof level. Some reduction in column sizes were noted at upper levels, but a detailed survey was not carried out, due to the unsafe state of the building. Storey heights were 3m, except for the ground floor and basement which had storey heights of 3.6m. The infill blockwork comprised 180mm thick hollow clay tile, except in the basement, where hollow concrete block was used. The columns at ground floor level had about 1% vertical and .3% transverse steel, with no indication of closer spacing at column ends. The shear wall (gridlines 2, D-E) appeared to have about .2% steel vertically and .15% horizontally in each face, with no evidence of special confinement to the vertical edges. These estimates are based on the exposed steel visible on the surface of some of

The state of the building appeared perilously close to collapse. The major damage was at ground floor level, with none visible in the basement and little at higher levels (though a detailed inspection was not made). The central shear wall was very heavily damaged with the concrete reduced essentially to rubble and the reinforcement clearly visible. There was severe spalling at many of the top and bottoms of the ground floor columns between gridlines B and H (which provided the resistance to east-west motions); little damage could be seen in the other columns which provided north-south resistance. The stair slab had fractured at ground floor level, where the single mat of steel had pulled completely out of the concrete. There was also heavy damage to the stair slab at first floor level.

It can be seen from Figure 4 that the structure was reasonably uniform on plan; an analysis by EEFIT has shown that the ratio of torsional to translational stiffness conformed to the limits required for regular structures in the Japanese Building Standard Law (IAEE, 1988). The vertical regularity was also reasonable, although the ground floor height was 20% greater than that of upper floors, and the building damage was concentrated at ground floor, indicating a weak storey at that level. The vertical regularity was therefore checked by performing a response spectrum analysis of the building, using the 5% damped spectrum recorded in Erzincan, and was also found to comply with the Japanese limits (Aoyama, 1981) for variation in storey drift with height of structure .

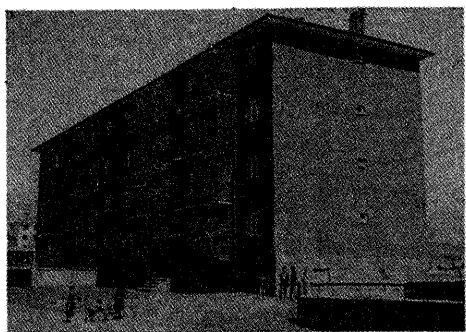
A study was made of an estate of 4 storey apartment buildings in the Fatih district in the north east of Erzincan (Plate 3). The apartments consisted of two apparently very similar types of apartment, which had however performed rather differently. There were about 18 older apartments of the first type (plate 4) to the south of the site. They had four above ground storeys and a semi-basement about half of which was above ground level. The structure consisted of concrete frames with clay tile infill; some apartments had their major axes oriented east-west and others north-south. There was little evidence of damage externally in any of these older apartments; internally there was extensive severe cracking to the infill panels (but no collapses were noted) and hairline cracking could be seen in some beams and columns. The occupants were not sleeping in these apartments but used them during the day for washing etc.

Plate 4: Older apartment building

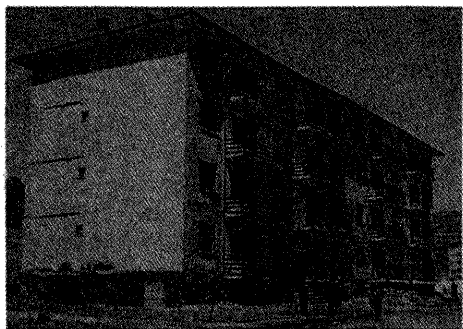
To the north were 8 more recent apartments (Plate 5) of similar construction to those discussed above. 2 of the 4 apartments with their long axis in a north south direction had collapsed and had been demolished; the 2 others in the same direction had suffered a failure in their semi-basement (Plate 6). There was less apparent damage in the blocks oriented at right angles.

Plate 5: Newer apartment building

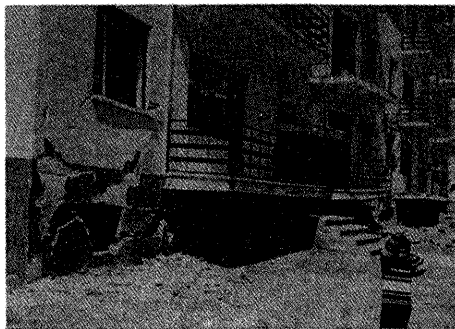
- 4) Semi basements in concrete frame buildings, where the basement walls are created by infill blockwork were prone to collapse. This was attributed to the creation of a brittle storey between ground level and the first suspended floor. Similar buildings with concrete walls at basement level performed much better.

Plate 6: Close up of Plate 5 showing failure in semi-basement

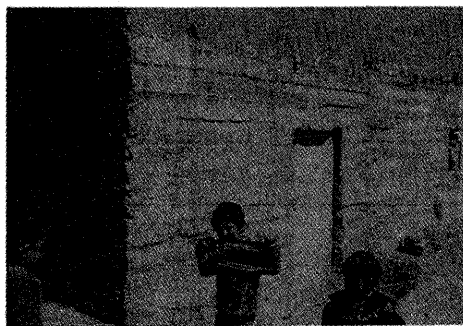
The structural difference between the two types of blocks was that the older blocks were provided with concrete walls between basement and ground floor level (Plate 7), whereas in the newer blocks, the concrete frame continued to foundation level and was infilled with concrete blockwork. Plate 8 shows an adjacent block under construction with this detail. The newer (and presumably cheaper) construction practice had apparently resulted in the creation of a stiff but weak and brittle storey with columns whose shear strength was less than their flexural strength. This detail should therefore be avoided.

Plate 7: Semi-basement wall construction in older apartment building

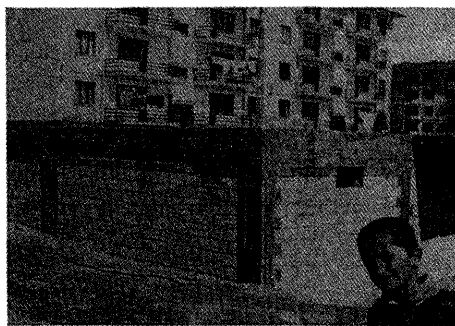
Plate 8: Semi-basement wall construction in recent apartment building
