FINDINGS OF THE UK INVESTIGATION OF THE 1992 ERZINCAN EARTHQUAKE

Martin S. Williams¹

ABSTRACT

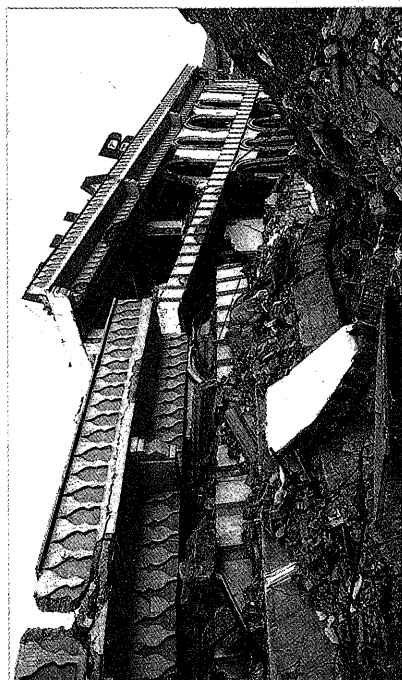
The majority of mid-rise RC structures were located on the two main streets in Erzincan, running north-south and east-west. The proportion of these which collapsed or were damaged beyond repair may be as high as 40% [3]. Most of the collapses were of the bottom-up type, with failure first occurring at the ground floor level, and sometimes spreading to the upper storeys as the structure fell. In most instances, however, bottom-up collapses were restricted to the bottom one or two storeys, with complete failure at all levels relatively rare (Figure 2). Soft storeys at ground floor level were probably the most common cause of bottom-up collapse. These were extremely widespread among the major buildings on the two main streets of the city, where nearly all ground floors were used as shops. Several collapses were initiated by a series of short columns at semi-basement level, where windows frequently spanned the full width between columns. Weak column-strong beam design was also observed in numerous structures.

Figure 2 Bottom-up Collapse of RC Building in Karaağaç District, with Partial Survival of Upper Storeys

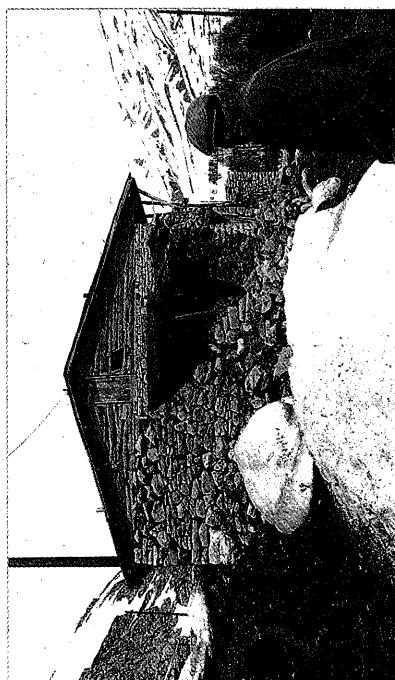
Figure 4 Partial Collapse of a Stone Masonry Building in the Mountain Village of Mecediyeh

Structures with stone or adobe block walls generally fared very badly in the earthquake, particularly in cases where the roof was of the heavy, compacted earth type (Figure 4). In addition to shear failures of the walls, many roof collapses were caused by a loss of bearing as the supporting walls moved. In buildings where roof joists protruded well beyond the walls or were supported by timber props just inside the walls, cases of roof collapse were considerably fewer. Himis houses suffered moderate levels of damage, with spalling of plaster and loss of infill adobe blocks, but cases of collapse were comparatively few, due to the ability of the timber frame to sustain very large displacements without failure.

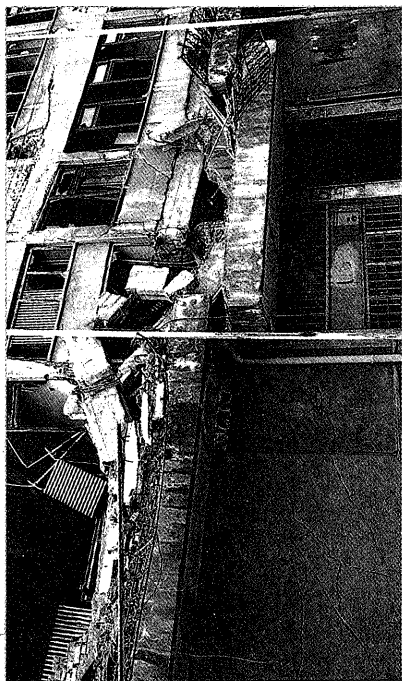
There was a small number of mid-storey collapses, in which one storey was lost while floors both above and below remained relatively undamaged (Figure 3). Only one case of top-down collapse was observed; this type of failure usually involves structures of more than six storeys, and so would not be expected to occur widely in Erzincan.

Figure 3 Mid-Storey Collapse of RC Building in Karaağaç District, other Floors Severely Damaged

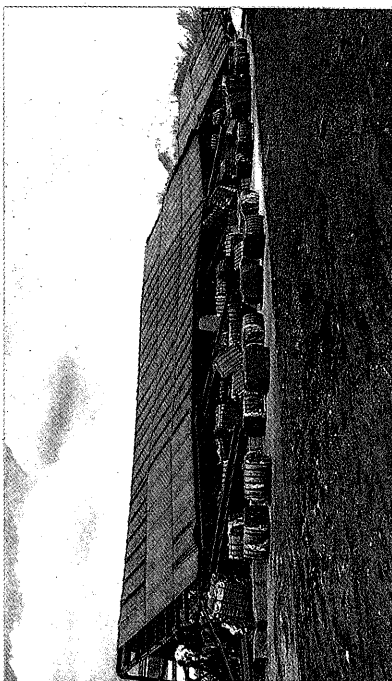
Figure 5 Westwards Failure of Steel Storage Shed at the Sumerbank Textile Factory

Secondly, it was found that the majority of structures collapsing on an east-west axis fell to the west, while those failing along a north-south axis mostly fell southwards. This characteristic was noted for individual members as well as for structures, with west and south facing walls of buildings suffering out-of-plane failures at a far greater frequency than east or north facing ones.

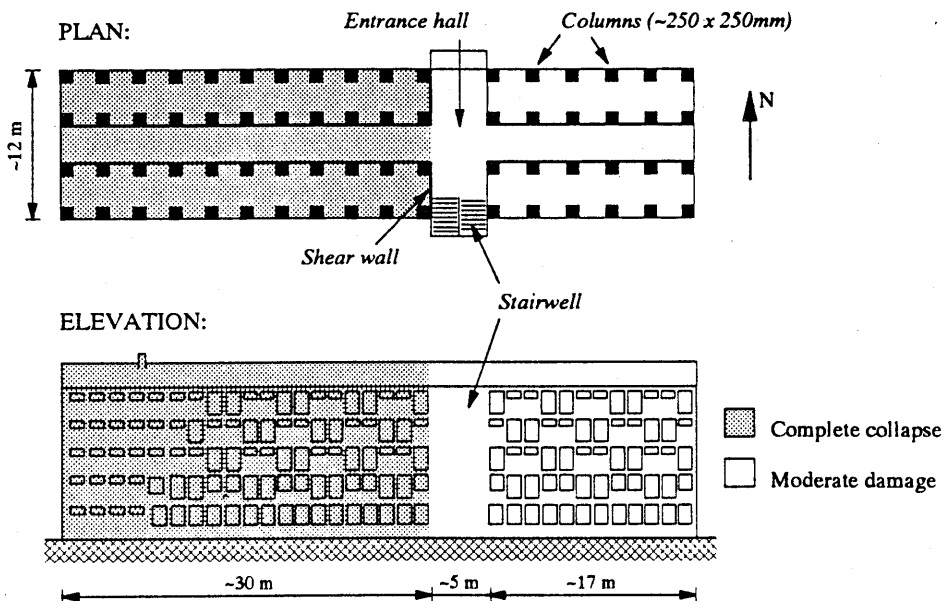
Figure 6 The Nursing School; Typical Floor Plan and Elevation Showing Distribution of Window Openings (not to scale)

The state hospital consists of six major buildings occupying a site very close to the city centre (see Figure 1). Of these, the two storey obstetrics building constructed in 1980, the three storey chest hospital built in 1990 and two smaller single-storey buildings suffered only minor damage. The most serious damage occurred in the nursing school, a five storey building with basement constructed prior to the introduction of the 1977 earthquake code, illustrated in Figure 6. The western half of this building collapsed

completely, killing 22 of the approximately 50 occupants. Referring to Figure 6 a number of structural features which may have contributed to the collapse can be identified.

Firstly, while there was a transverse shear wall just to the west of the entrance hall, there were no longitudinal shear walls; the main longitudinal walls are unlikely to have acted as shear walls due to the large number of door and window openings. Secondly, the uneven layout of window openings would have caused an uneven distribution of horizontal load throughout the structure. A further source of stiffness eccentricity was the single stairwell located on the south side of the building. There were also numerous locations where short columns may have developed between windows. Lastly, the long axis of the building ran east-west, with the collapse occurring on the western side.

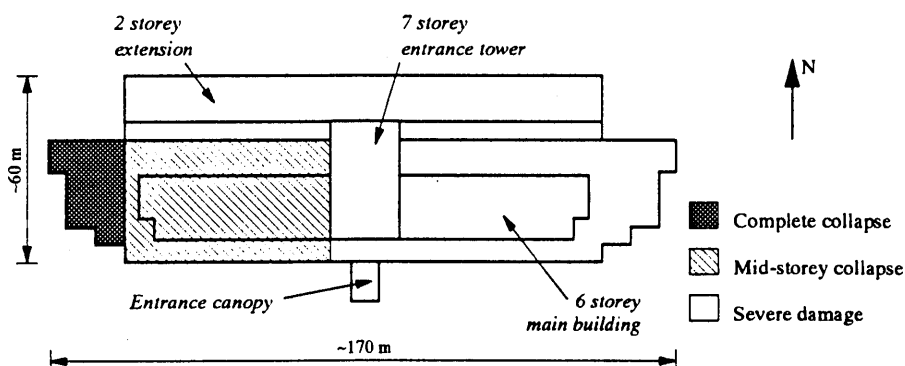
Figure 7 Plan View of Military Hospital (not to scale)

This large six-storey structure, located to the north of the city, is shown in plan in Figure 7. While most of the building had a very regular, uniform configuration, the vulnerability of the end sections was increased by the large number of re-entrant corners. The earthquake caused complete collapse of the section at the western end, a mid-storey collapse in the remainder of the western half, and severe structural damage to the rest of the building. Inspection of photographs of the structure prior to the earthquake suggested that a soft storey was the most likely cause of the collapse, though it is possible that there was also some pounding from the low-level extensions to the north of the main structure. A military spokesman told EEFIT that there were no fatalities in the hospital, which had around 80 occupants at the time of the earthquake.
