# **A PRELIMINARY REPORT ON THE ERZİNCAN EARTHQUAKE, MARCH 13, 1992**

R. YARAR<sup>1</sup>, J. EISENBERG<sup>2</sup>, F. KARADOĞAN<sup>3</sup>

## **SUMMARY**

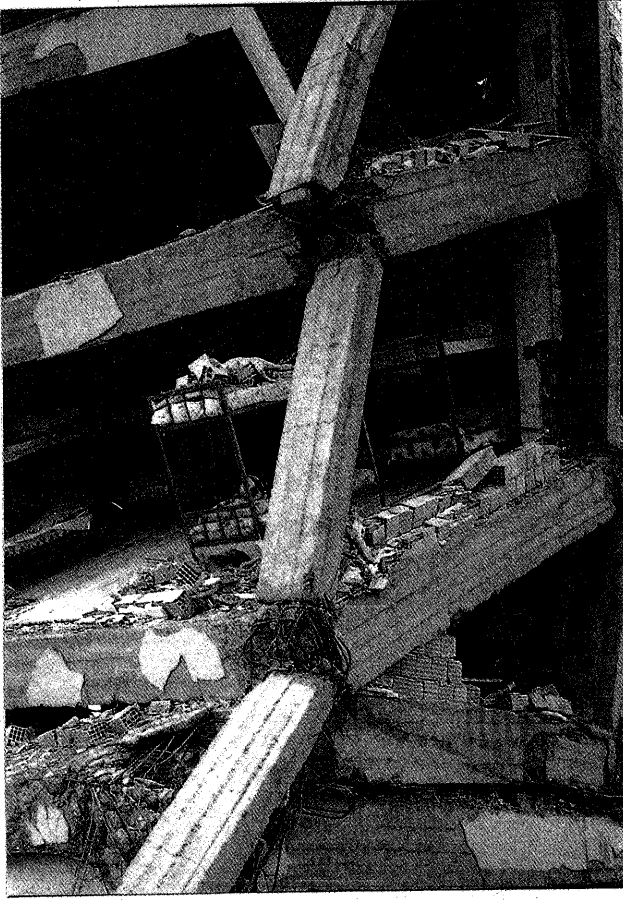
Photo.-1

Low quality concrete, poor design, poor detailing and poor construction are the other important factors which should be considered in the process of damage evaluation. Low compressive strength and poor bond between concrete and mild steel used generally, unsatisfactory and improperly placed confinements in columns, beams and beam column connections, weak column-strong beam connections are observed as illustrated in (Photos 1-6)
