DAMAGE CONTROL INDICES FOR REINFORCED CONCRETE BUILDINGS

Semih S. Tezcan ⁽¹⁾, Ragıp Akbaş ⁽²⁾

ABSTRACT

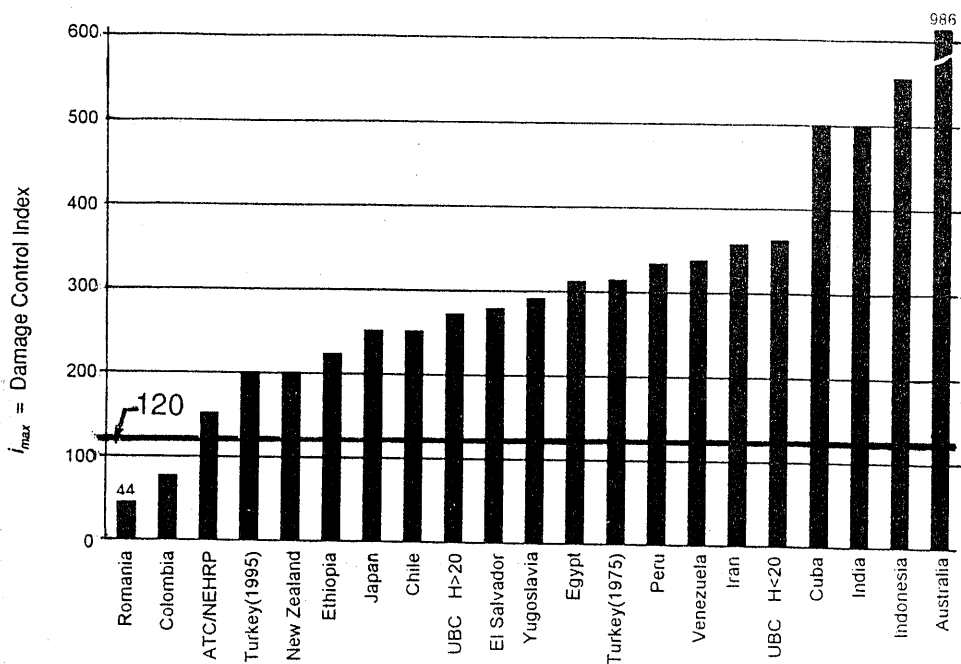
FIGURE 1. – DAMAGE CONTROL INDEX BASED ON EARTHQUAKE CODES

is defined as the *damage control index*, and listed in the last column of *Table 1*. It is not a surprise that, similar to storey drift limitations, the damage control index, i_m , also varies within a very wide range. The lowest value is $i_m = 44$ in Romania, and the highest value is $i_m = 986$ in Australia, as illustrated in *Fig. 1*.

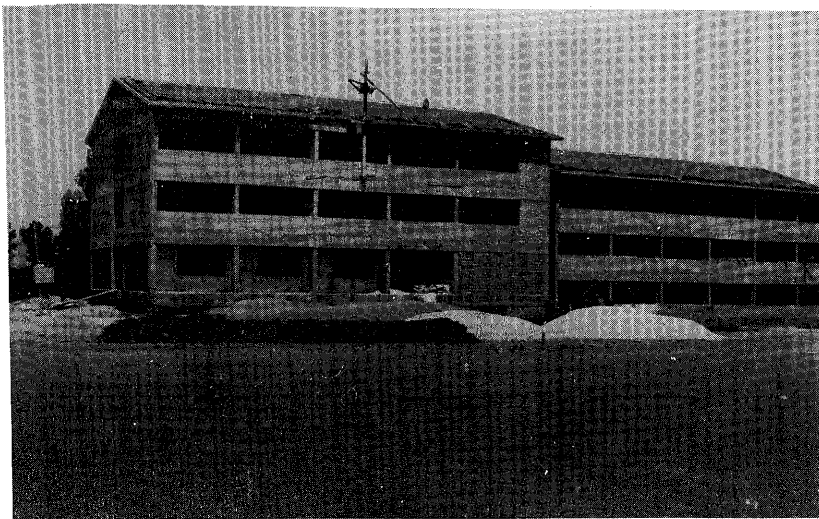
FIGURE 2. – HIGH SCHOOL BUILDING
(May 12, 1971 Burdur, Turkey)

The high school building shown in *Fig. 2*, was under construction at the time of the May 12, 1971 Burdur earthquake ($M = 6.2$). Due to heavy structural damages, which occurred at the basement and ground floor, this four storey frame building had to be demolished after the earthquake [12].

The lateral deflections, storey drifts as well as the damage control index values of the building frame along the axis No. 15, before and after the addition of shear walls are all listed in *Table 2*. The base shear coefficient is assumed to be $C = 0.06$, as recommended by the Turkish Earthquake Code, valid at that time. The influence of infill walls are neglected in calculating the lateral rigidities. The modulus of elasticity of the concrete is assumed as $E = 21\,000\text{ MPa}$.

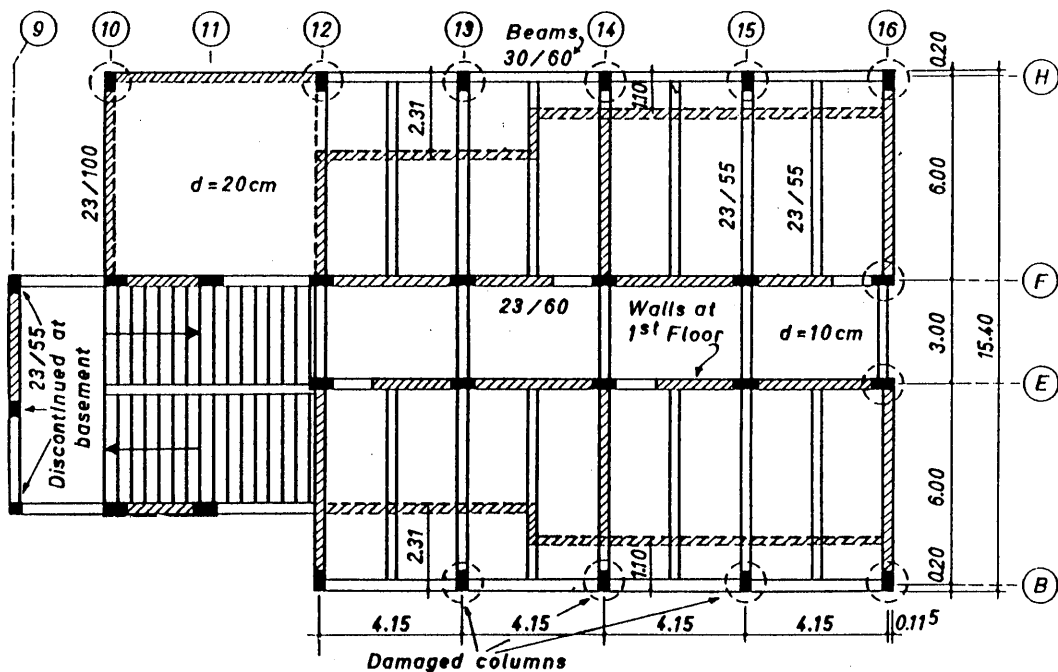
FIGURE 3. – FLOOR PLAN - HIGH SCHOOL BUILDING

The floor plan is given in *Fig. 3*. The high school was one of the typical schools constructed elsewhere in Turkey and was designed and constructed under the strict supervision of the Ministry of Public Works. The typical structural system has been drastically revised, and extensive shear walls have been added in both directions, after this particular building was damaged during the Burdur earthquake.

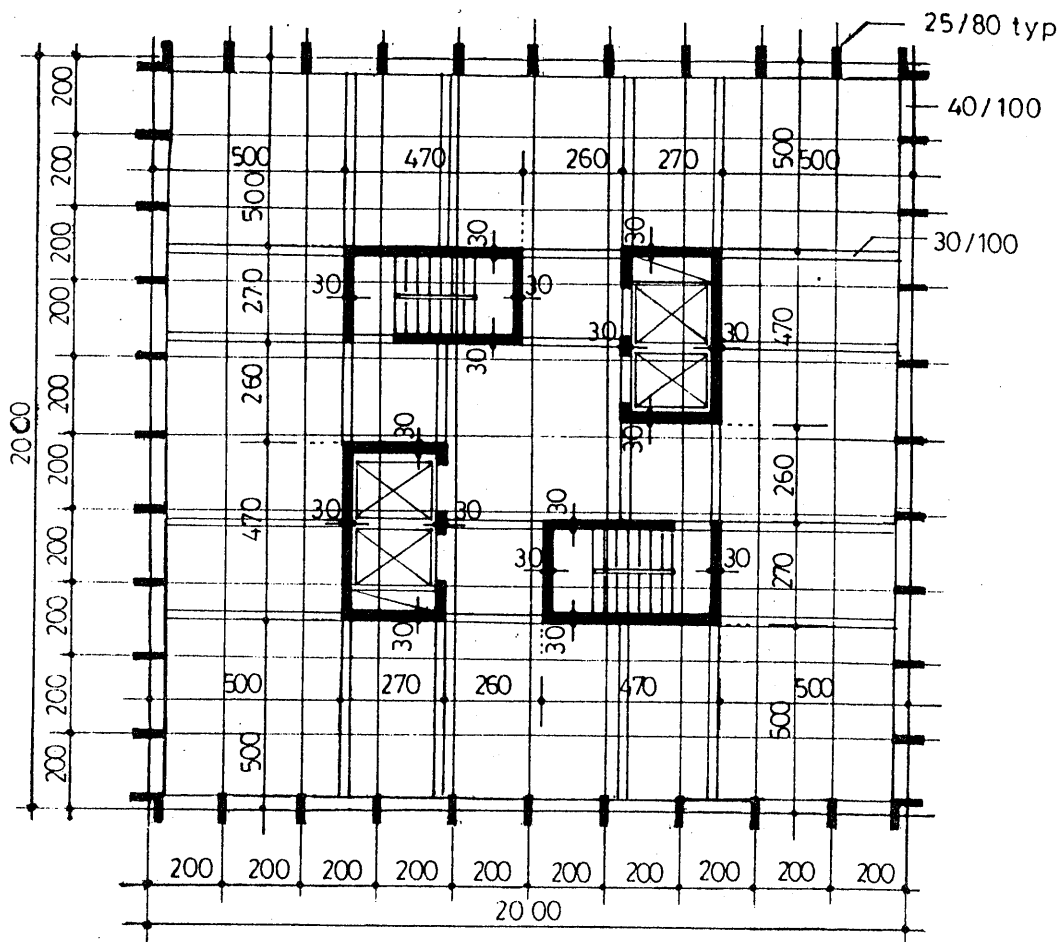
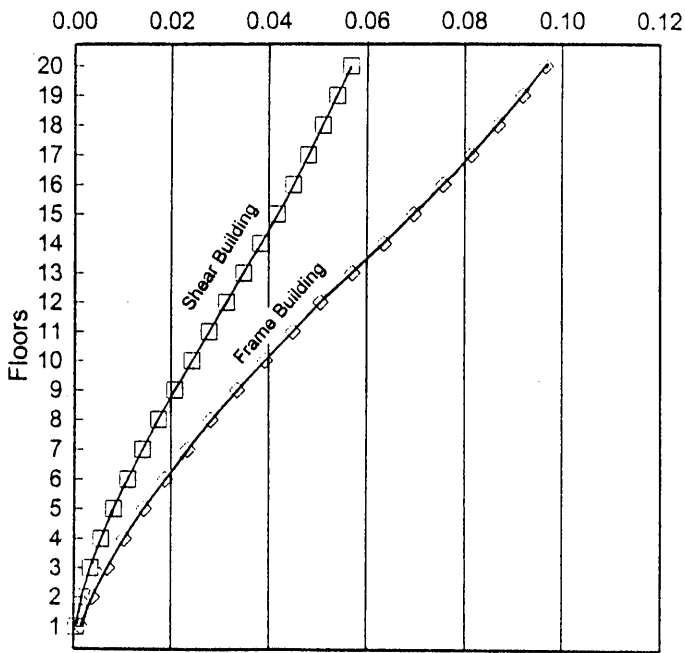
Assuming the building is located in the highest earthquake hazard zone, and following the methodology as contained in the new draft Earthquake Code of Turkey [11], the lateral deflections as well as the storey drifts have been calculated and listed in **Table 5**. The same values are also diagrammatically illustrated in **Fig. 9** and **Fig. 10**.
