STRUCTURAL FIELD STUDIES AFTER THE ERZINCAN TURKEY EARTHQUAKE OF 13TH MARCH 1992

Edmund Booth (Ove Arup & Partners, London)

ABSTRACT

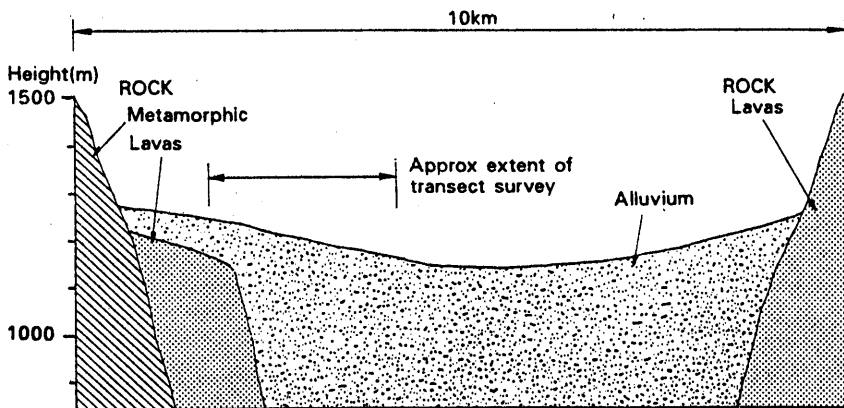
Figure 2 Cross section through Erzincan basin, at Erzincan, looking east. (Based on hydrogeological survey, 1981)

A simple damage survey was made to try and establish whether ground motions in Erzincan had varied systematically with distance from the edge of the Erzincan basin. The survey was conducted along a north south line across the city, just to the west of the city centre (figure 1). Based on a hydrogeological survey map dated 1981, it appears that the depth of sedimentary material varied considerably along the survey line (Figure 2).
